LESSONS LEARNED IN HIGH-PRESSURE HIGH-TEMPERATURE WELL COMPLETION IN VIETNAM

Summary

Key words: High-pressure and high-temperature (HPHT), well completion, IOR/EOR, Nam Con Son basin.

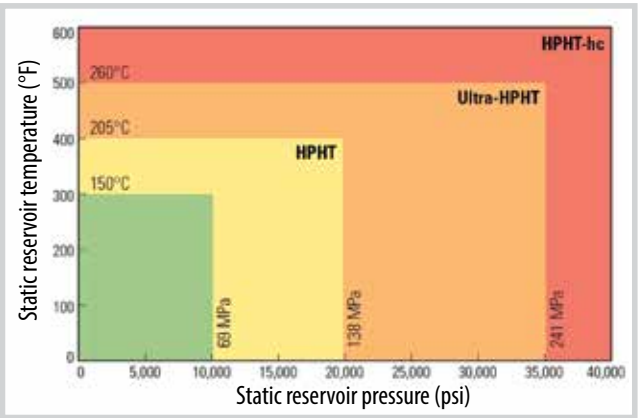
Figure 1. HPHT thresholds [1].

In recent years, the definition of “high-pressure high-temperature” (HPHT) wells has varied across companies and oil and gas associations. The American Petroleum Institute (API) classifies HPHT wells based on its guidelines for specialized HPHT equipment. According to API standards, a well is classified as high-temperature if the static temperature at the total depth exceeds 350°F (approximately 177°C), and as high-pressure if the shut-in surface pressure exceeds 15,000 psi (approximately 103 MPa). Wells exhibiting one or both criteria are categorized as HPHT wells. Meanwhile, the Society of Petroleum Engineers (SPE), the International Association of Drilling Contractors (IADC), and several multinational oil companies (such as Schlumberger) use a slightly different thresholds, setting high-temperature at 300°F (around 149°C) and high-pressure at 10,000 psi (around 69 MPa), as shown in Figure 1.
